**Naval Station Everett
Small Craft Piers Delta and Echo
Replace or Repair Analysis
With Recommendations**

**Written by
Ben Leppard**

**Professional Project
University of Washington
Construction Management**

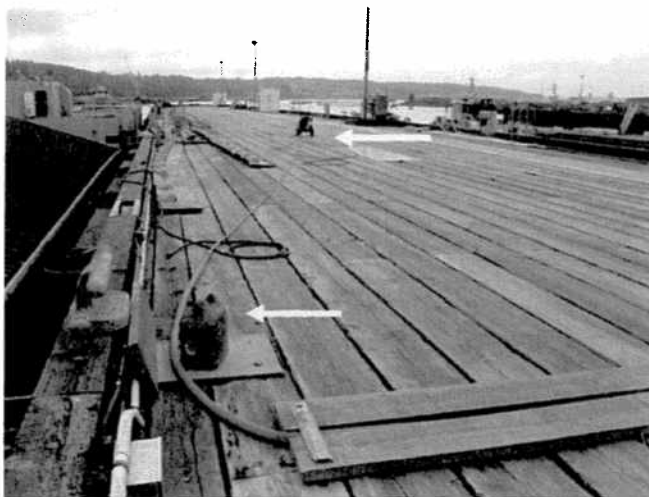
Figure 29 – Temporary utilities on pier deck

Utilities – Virtually nonexistent on the pier, forcing Port Operations to emplace temporary water lines and other utilities, as necessary. Functional electrical power runs to the office YFN on Pier Echo.
